Fox Meadow MA
E. 9th and WCR 1
Longmont, CO 80501

Level 2 Reserve Analysis

Report Period – 01/01/12 – 12/31/12

**Final
Version**

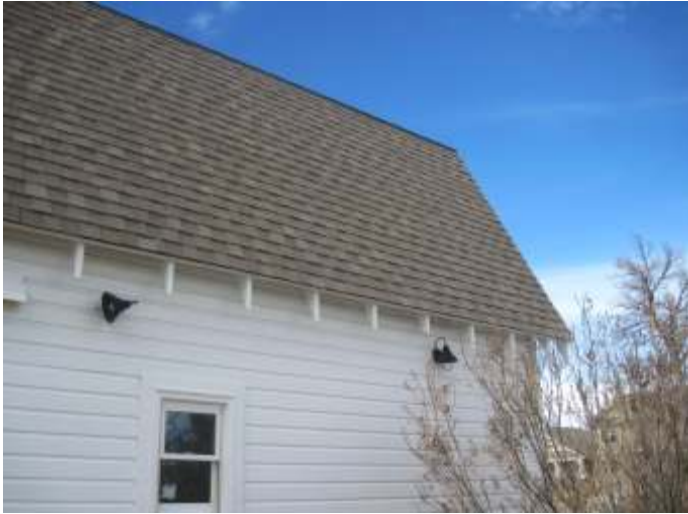
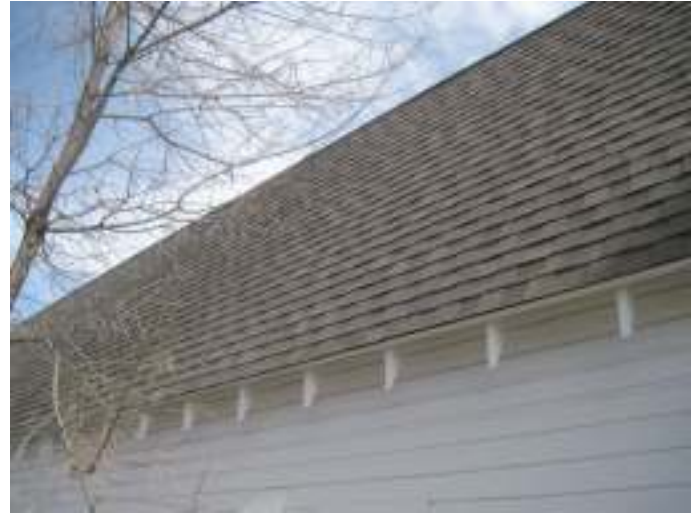
Comp #: 105 Pitched Roof - Comp Shingle - Replace

Roof appeared in good to fair condition at time of observation with only minor surface granule loss visible. While this roof material may have a rating of 30 years from the manufacturer, the average life expectancy for this type of material ranges from 20 - 25 years in our environment. Factors that contribute to a shorter life expectancy include small hailstorms, high winds, temperature fluctuations, etc. The remaining life is based on observed conditions and age..

Best Cost: **\$7,150**
\$325/square; Estimate to remove and replace

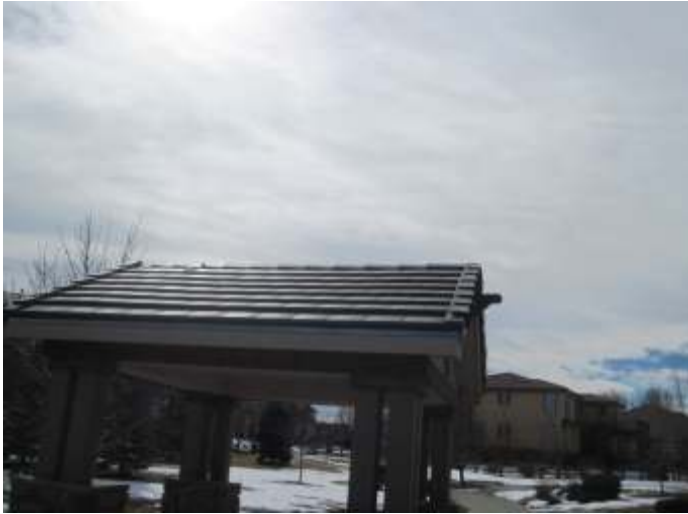
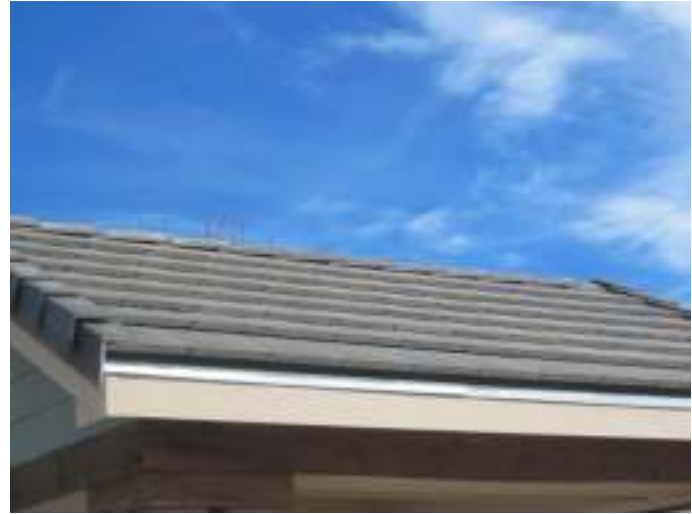
Comp #: 106 Pitched Roof - Slate Tile - Replace

Roofs appeared in good condition at time of observation with no broken or missing tiles note. Typically, the felt roof material has a useful life of approximately 25 years before deterioration causes significant roof leaks. Reserve to completely remove and replace felt underlayment. This is a very labor intensive job as all the tiles will need to be removed for the underlayment to be replaced. According to local contractors, a 10% allowance should be included for tile breakage.

Best Cost: \$3,000
\$500/square; Estimate to replace underlayment

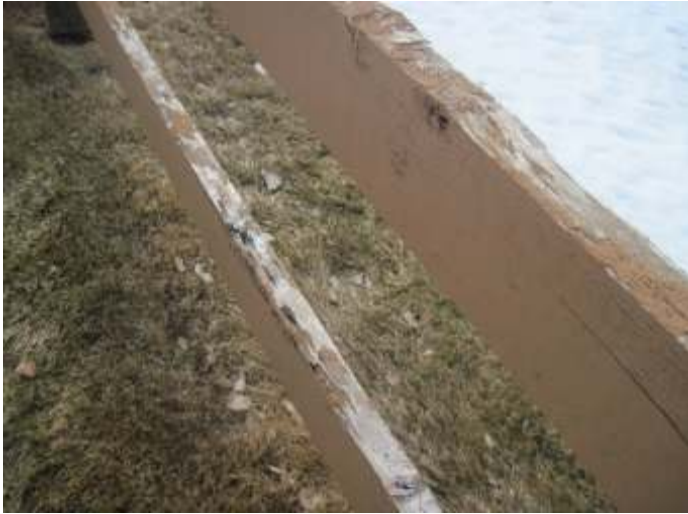
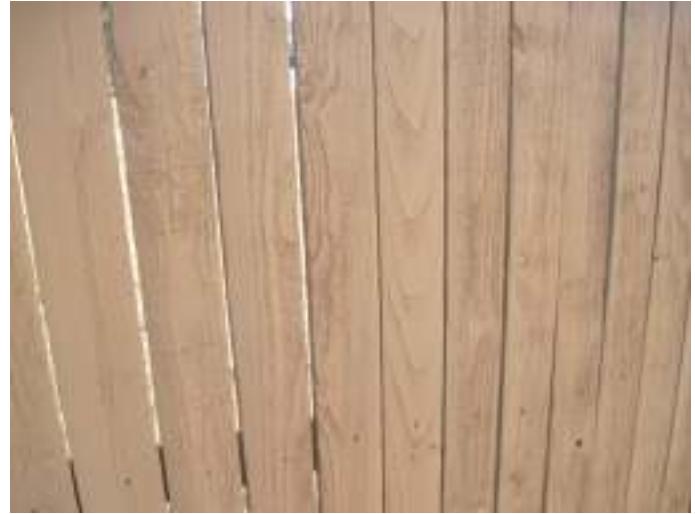
Comp #: 209 Wood Fencing - Restain

It was reported that the fencing was stained in the Spring of 2010. The fences are in need of staining again this fiscal year due to thin, peeling and bare wood surfaces apparent at time of observation. Due to client history and the current conditions of the fence stain, we are recommending that the association Reserve to restain all fencing every 2 years rather than the previously recommended 3 years. Staining every 2 years will provide a longer useful life of fencing and maintain an attractive and consistent appearance throughout the community. We also recommend routinely inspecting irrigation systems and diverting spray away from fence lines as this accelerates the deterioration of the stain. Remaining life based on observed conditions and age.

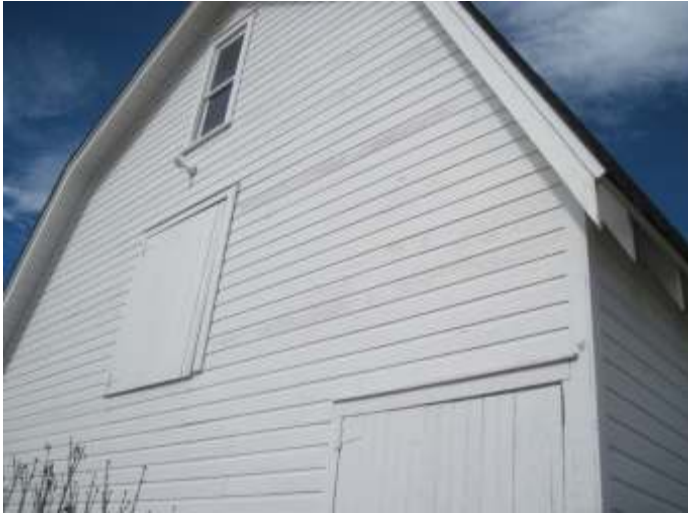
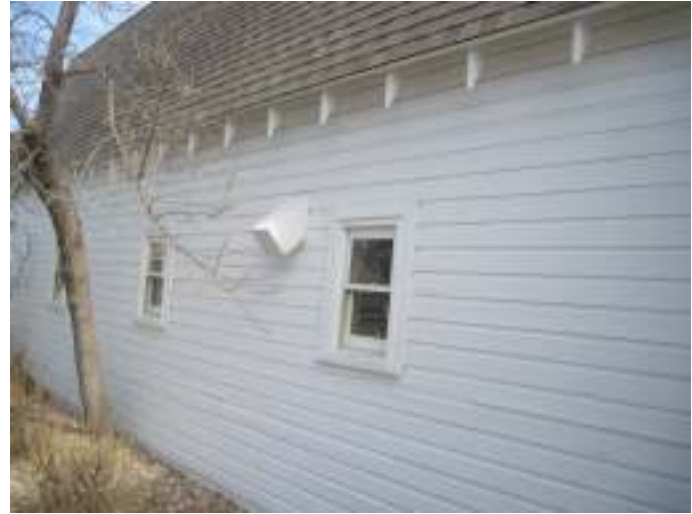
Comp #: 215 Wood Siding - Repaint

The barn appeared to have been painted within the last 2 - 3 years. The white paint was bright, even and free from marking or other damage. Some areas of the wood siding appear to be checking and may need to be replaced as a part of prep operations next time it is painted. The costs included in this line item reflect cost of repainting and some extra prep work costs. We recommend reserving to repaint the barn every 6 years as light colored paints tend to fade less from UV rays and shows less dirt than darker colors. Remaining life based on observed conditions and assumed age of paint.

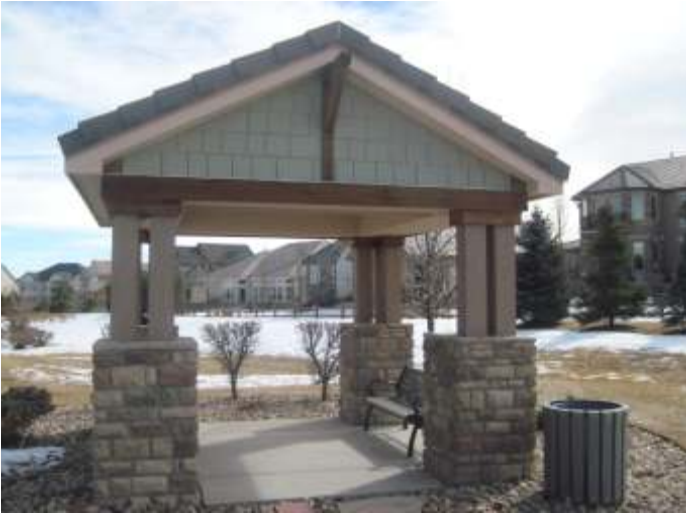
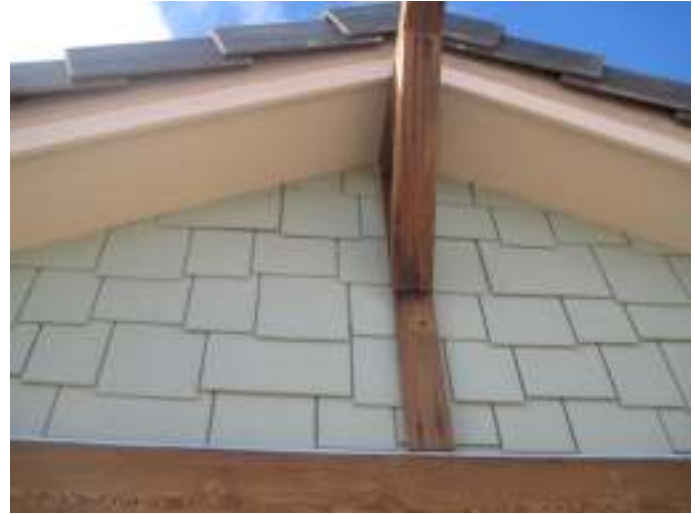
Comp #: 301 Shade Structure Siding - Replace

Siding appeared in good condition at time of observation with no unusual problems noted. The siding materials are in very good condition and should have a long life expectancy with proper care and maintenance. Due to the location in park areas, this material may be subject to abuse and vandalism over the years. We suggest planning on replacement of this material every 25 years due to the location. Remaining useful life based on observed conditions and age.

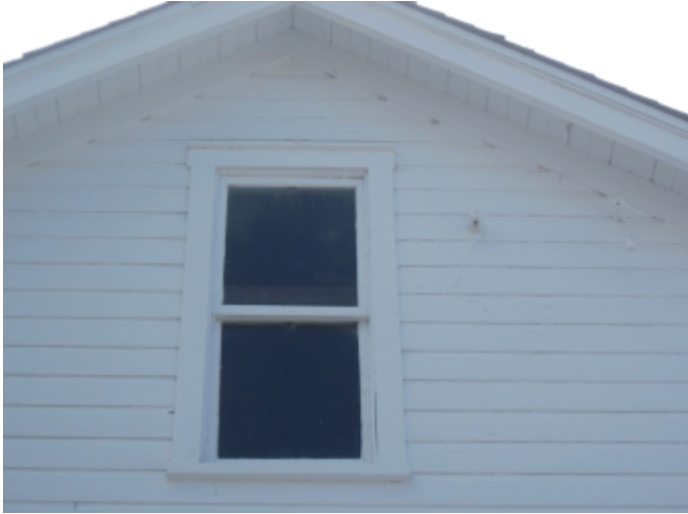
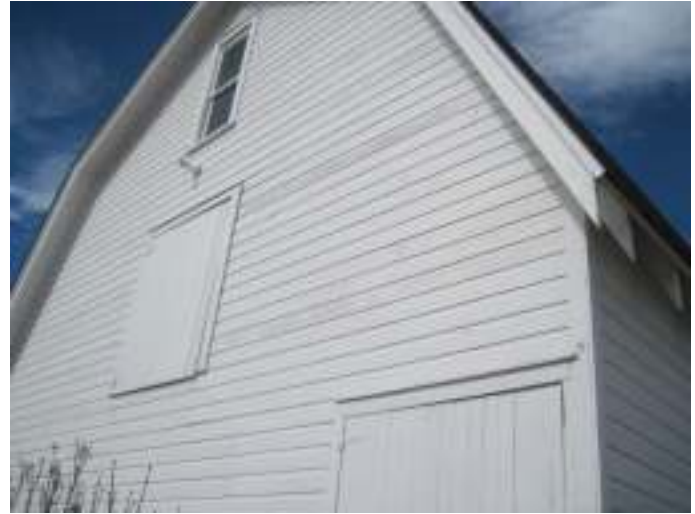
Comp #: 303 Wood Siding - Replace

The siding on the barn appears to have been well maintained since our last site visit and is in fair condition at time of observation. It was reported that the barn is used by community residents as a place to host barbecues and birthday parties during good weather months. Due to the appearance of the barn being better than our last observation, we have recommended a longer useful life. Continue to maintain the siding and inspect for any problem areas and make minor repairs as needed using operating funds. Remaining useful life based on observed conditions.

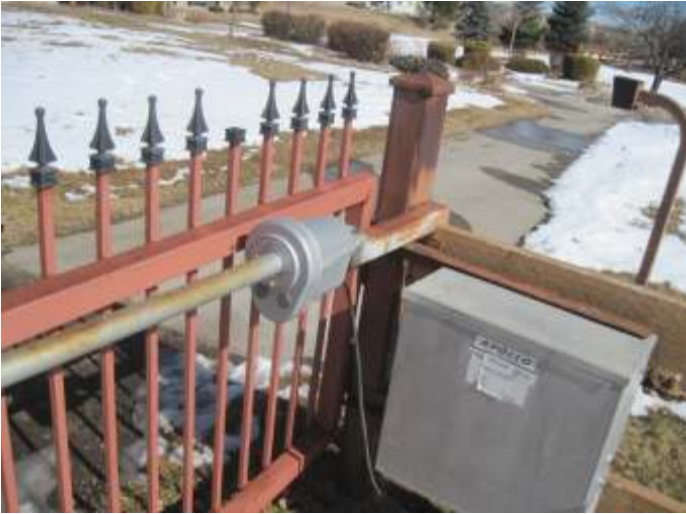
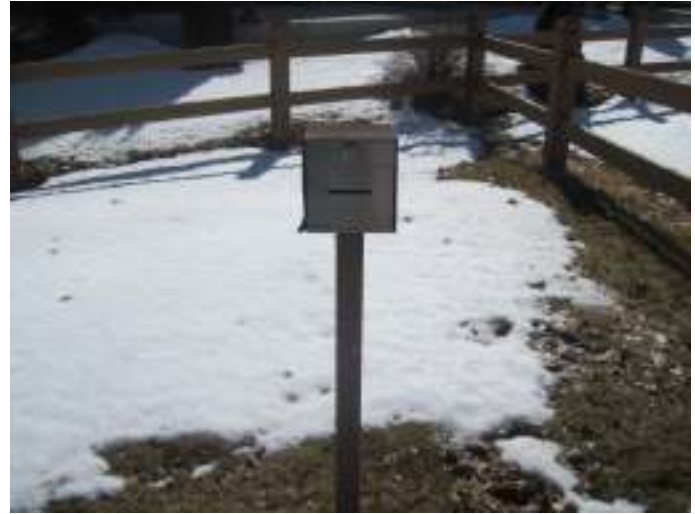
Comp #: 505 Vehicle Iron Gate - Replace

Gate was stuck in the open position at time of observation and it was reported that the gate and operator has had problems in the past. We recommend reserving to replace card reader and motor at the same time as both will have similar useful lives. The gate can be repaired and replaced at relatively low cost, use operating funds for any issue regarding the metal gate. Typical useful life for this type of system and that is subject to the elements is between 10 - 12 years not including acts of God or vandalism. Remaining useful life based on observed conditions and age.

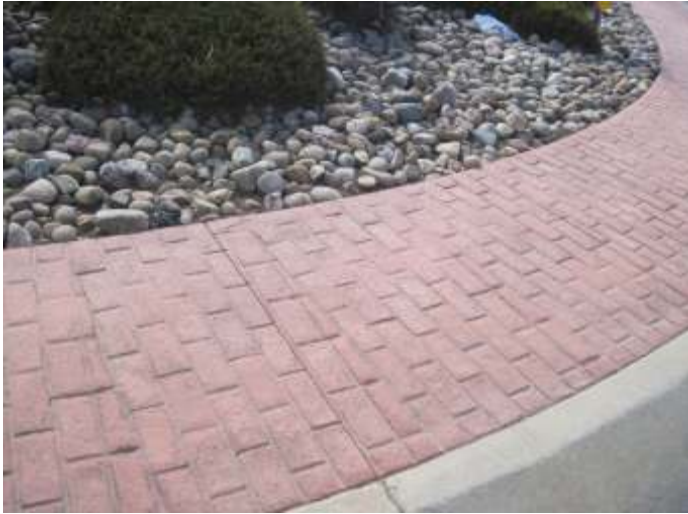
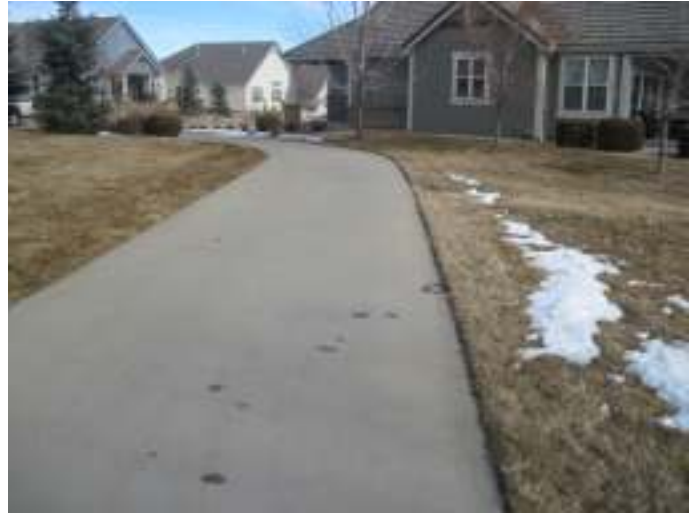
Comp #: 601 Concrete Sidewalks - Repair

We saw very few areas of new concrete in the community, we assume these repairs were made according to schedule and the community does not have any glaring concrete issues in the sidewalks or roundabouts. There continue to be a few hairline cracks noted on the stamped concrete surfaces in the roundabouts. While it is highly unlikely that all concrete will fail at the same time, we suggest planning on periodic repairs due to how our climate effects the concrete. We suggest continuing to reserve an allowance to replace 10% of area (3100 GSF) every 4 years. As the property ages, the percentage of repairs may need to be increased.

Allowance to repair 10% of area every 4 years

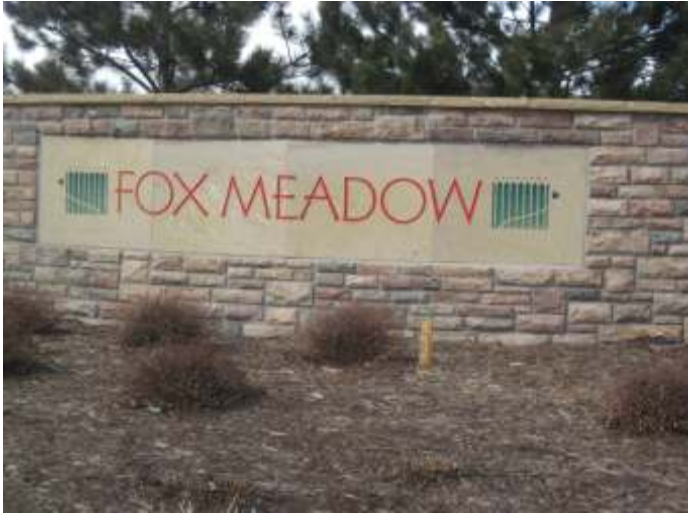
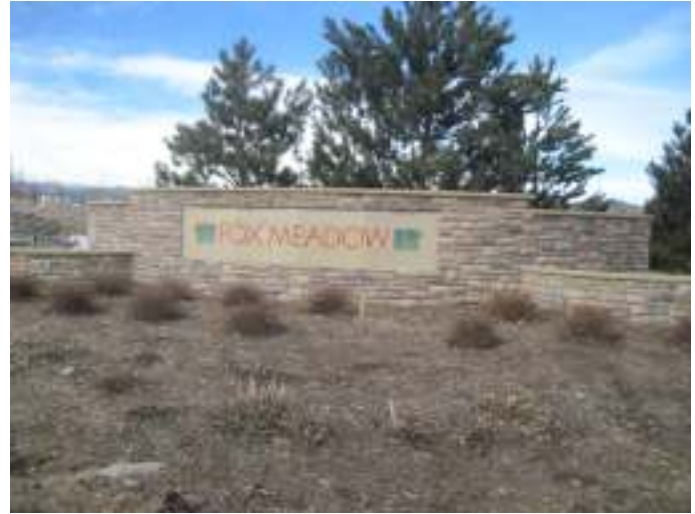
Comp #: 801 Monument - Rebuild

Monuments are still in good condition and stable with no damaged or missing components at time of latest observation. While the materials used in these structures should have an indefinite life expectancy, future renovations and rebuilding of structures will be necessary to keep up with modern trends. Most associations prefer to set up this major renovation schedule every 25 - 30 years. Remaining useful life based on observed conditions and age.

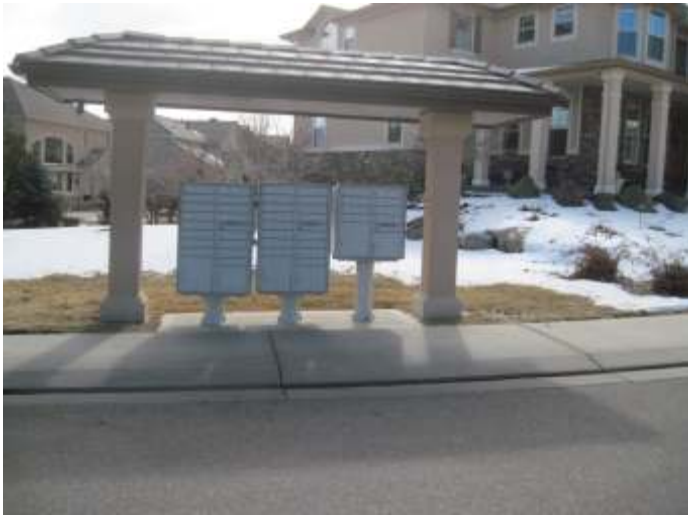
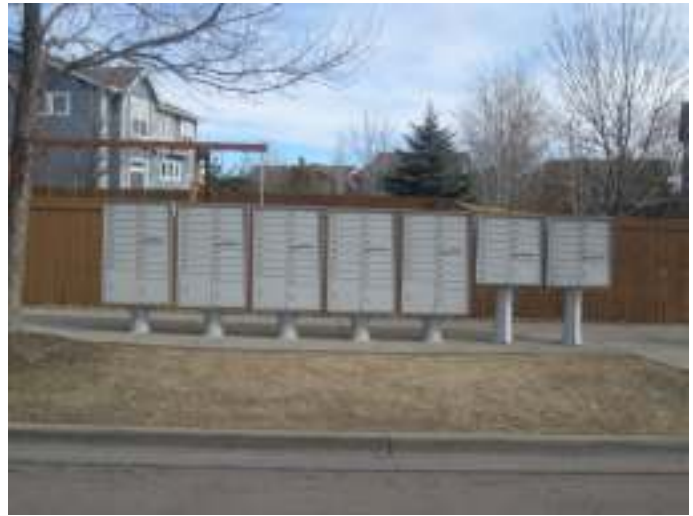
Comp #: 803 Mailboxes - Replace

It was reported at time of observation that the master association is not responsible for the replacement or maintenance of the mailboxes. The mailboxes were reported to be the responsibility of the individual sub-associations within the community.

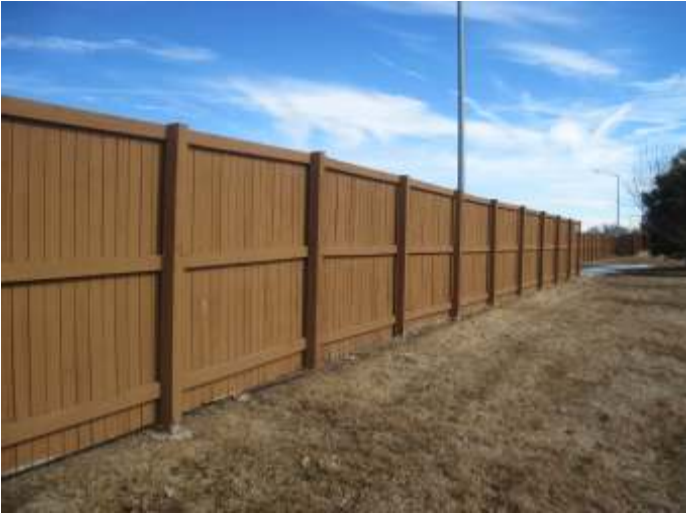
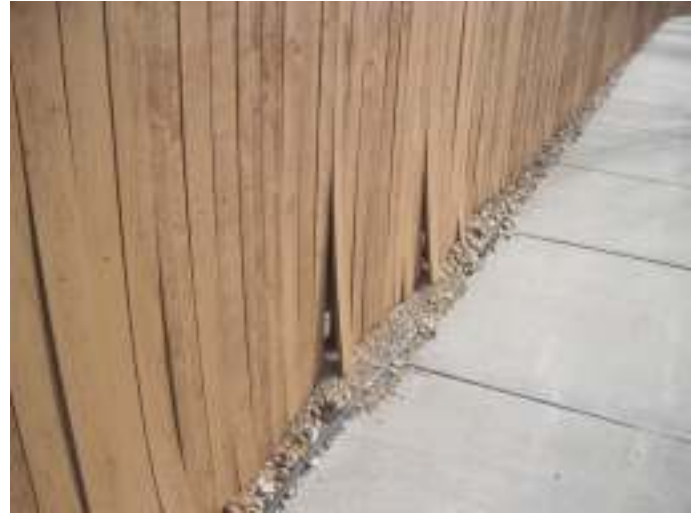
Comp #: 1001 Privacy Fencing - Replace

Fences, as reported in component #209, are in need of stain this fiscal year but the wood is in overall good to fair condition. Some other minor damage was noted at time of observation, including sections of fence along Deerwood that have many warped boards due to rock in a homeowner's yard impinging on the slats. We recommend repairing this section as an operating expense. Minor repairs and replacement boards are expected as part of prep costs before painting. However, complete replacement of the fence should be anticipated every 20 - 25 years as long as proper maintenance occurs over the years. Without proper maintenance, expect to replace the fence within 10 - 12 years. Remaining life base on observed conditions and age.

\$33/LF; Estimate to replace

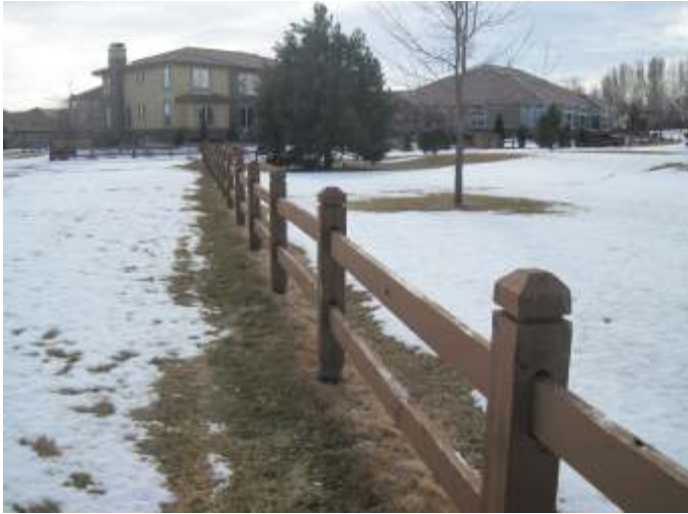
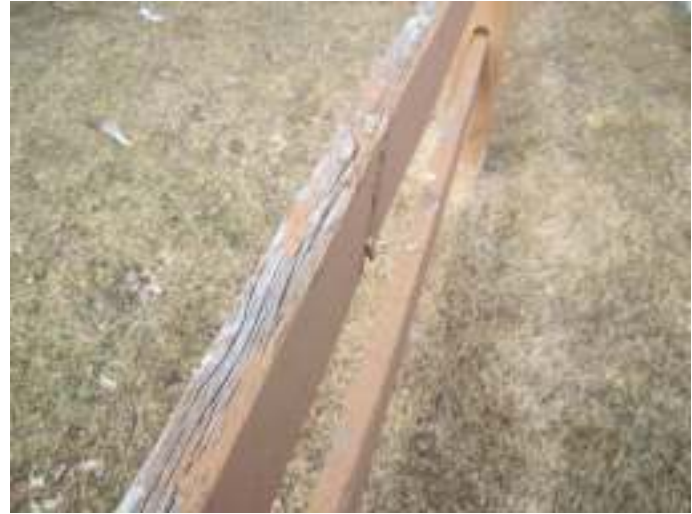
Comp #: 1009 Two-Rail Fencing - Repair

Rail fence appeared stable, plumb and in good to fair condition at time of observation. The rails tend to break easily from climbing, landscaping equipment, etc., the broken rails can be replaced individually as part of prep work before staining. We expect periodic repairs to be necessary, instead of complete replacement every 20 - 25 years. At time of observation, no broken or cracked rails noted or reported. We recommend continuing to reserve to make repairs every 6 years as it appears the maintenance plan is working. Remaining life based on observed conditions and age.

Allowance to replace 10% of area every 6 years

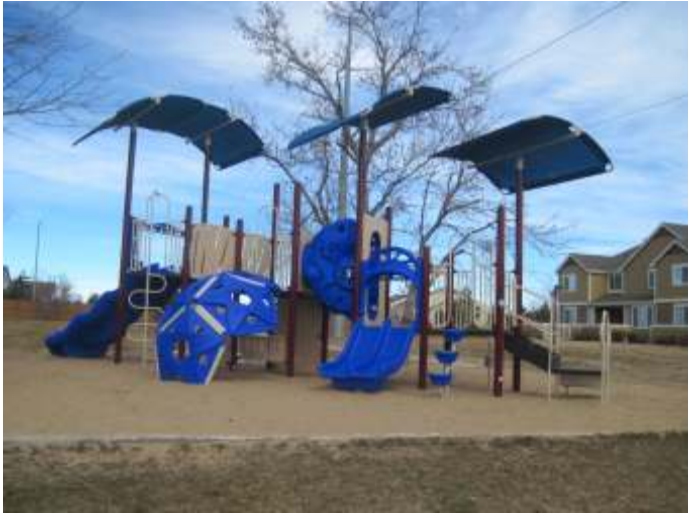
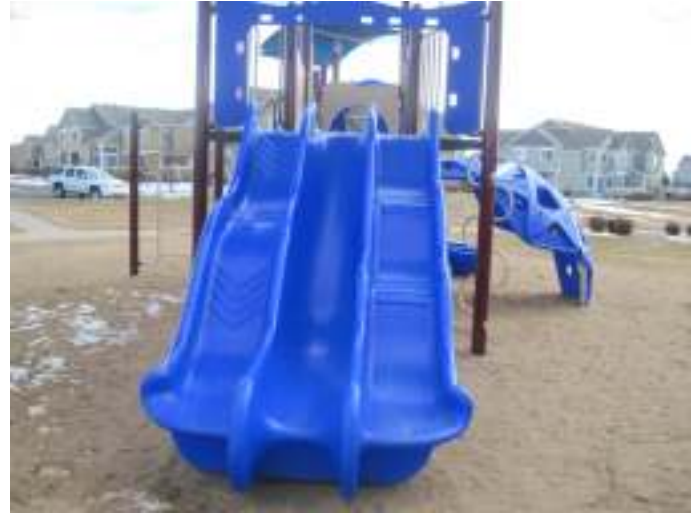
Comp #: 1301 Play Equipment - Replace

Structures were stable and in very good condition with no signs of abuse, mistreatment, or vandalism noted at time of inspection. Depending on overall level of use and care, the average life expectancy for play equipment ranges from 15 - 18 years. Expect high use for this facility due to the demographics of the community with the majority being young families with children. Remaining life based on observed conditions and age.

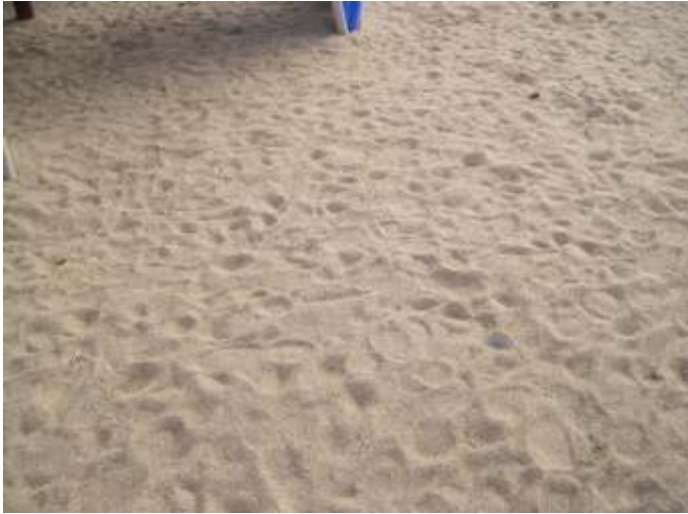
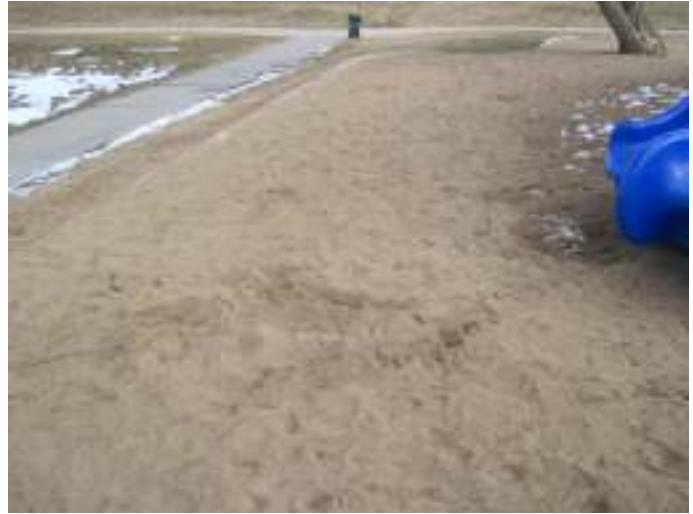
Comp #: 1303 Tot Lot Groundcover - Refill

Ground cover was in good condition at time of observation with no noticeable low or bare spots. We assume the sand was filled to specifications at time of play equipment installation. This material will be affected by wind, children, use and organics. We recommend reserving to replenish the sand box every 10 years barring any unusual circumstances that may arise (high winds, flood, vandalism, etc.). Between major refill operations, place small amounts of sand as needed using operating funds. Remaining life based on observed conditions and age.

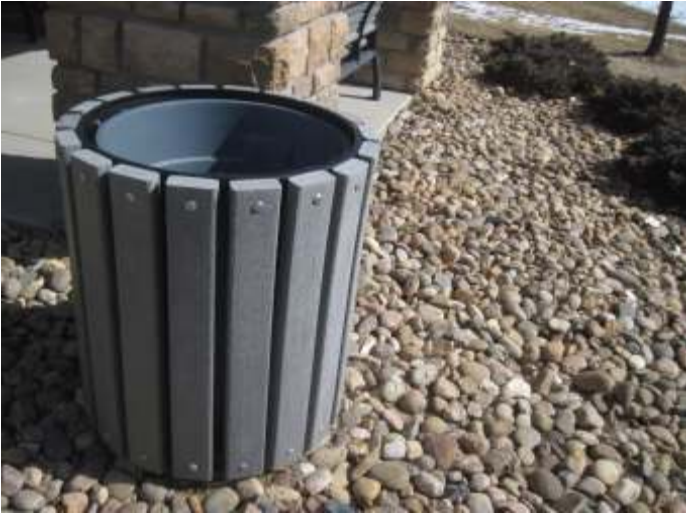
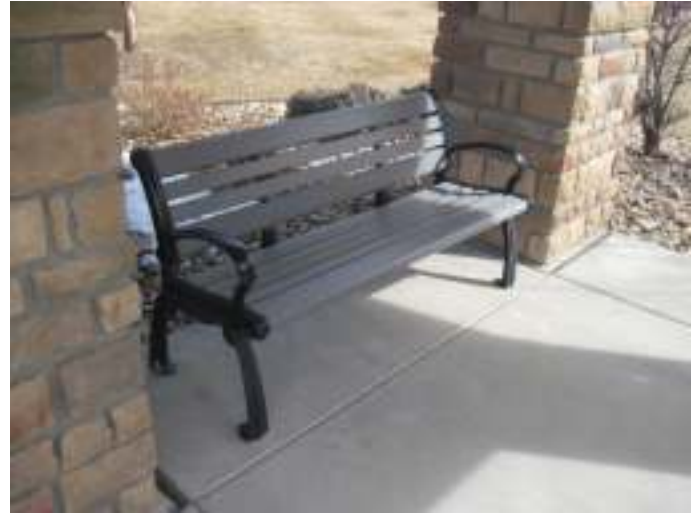
Comp #: 1306 Park Furnishings - Replace

All park equipment appeared in good condition at time of observation, prompting us to recommend a longer remaining useful life. Composite materials were fairly new at time of last observation in 2005 and it was unknown how the materials would perform in the harsh Colorado sunshine. Composite materials have an expected useful life of 15 - 18 years in normal conditions, we recommend reserving to replace the park furniture in the next 8 - 10 years in order to maintain a consistent and attractive appearance throughout the community. Remaining life based on observed condition and average age of all equipment age.

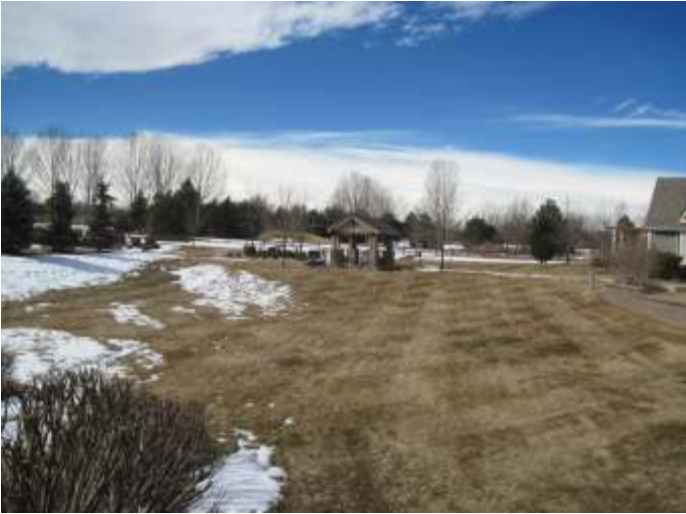
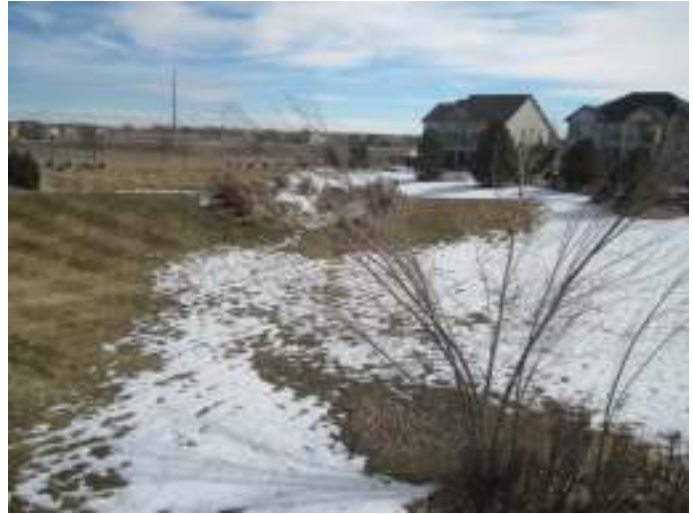
Comp #: 1701 Irrigation System - Rebuild

System was Winterized at time of observation, for more accurate assessments of the irrigation system schedule future updates during Summer months. Newer irrigation systems like this one are typically repaired on an annual basis with general operating funds. The materials used during construction should have a long life expectancy with proper maintenance. At this time, there is no expectancy to completely replace the system and Reserve funding is not recommended. If it later turns out that replacement will be necessary, expect to spend approximately \$500,000 for a new system.

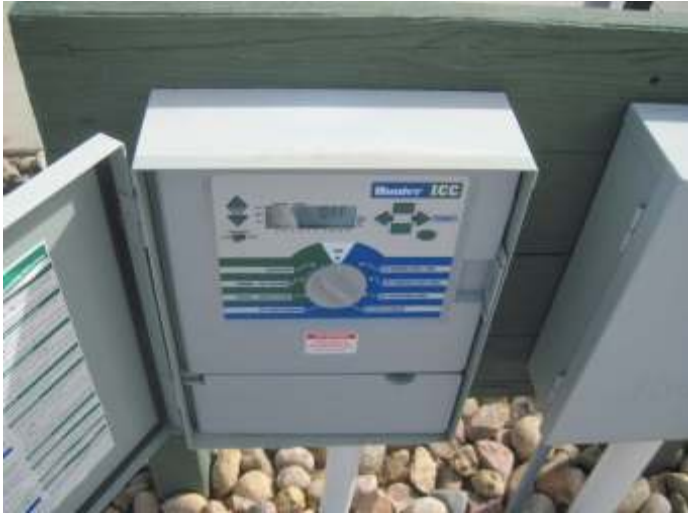
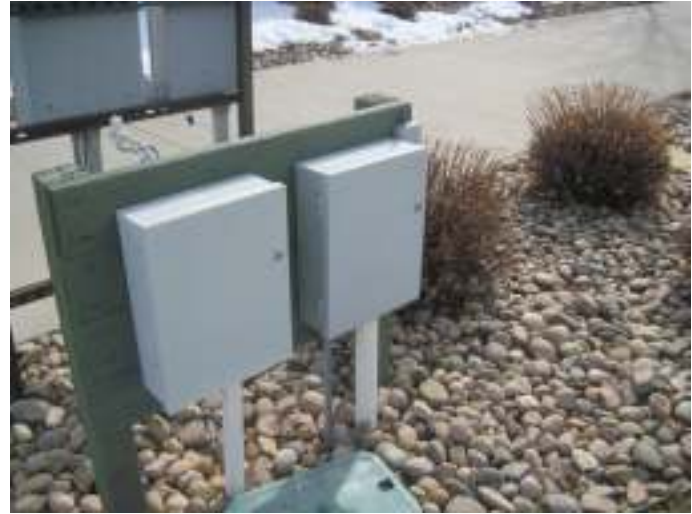
Comp #: 1703 Irrigation Timeclocks - Replace

System was winterized at time of observation, however, no problems reported while preparing this report. Under normal conditions (not including Acts of God, vandalism, etc.) these clocks should last 10 - 12 years with proper maintenance. Due to advances in technology and water efficiency, we suggest reserving to replace all clocks at the same time. A lot of communities are upgrading to ET type controllers and the costs reflect this. Remaining useful life based on average age of all clocks.

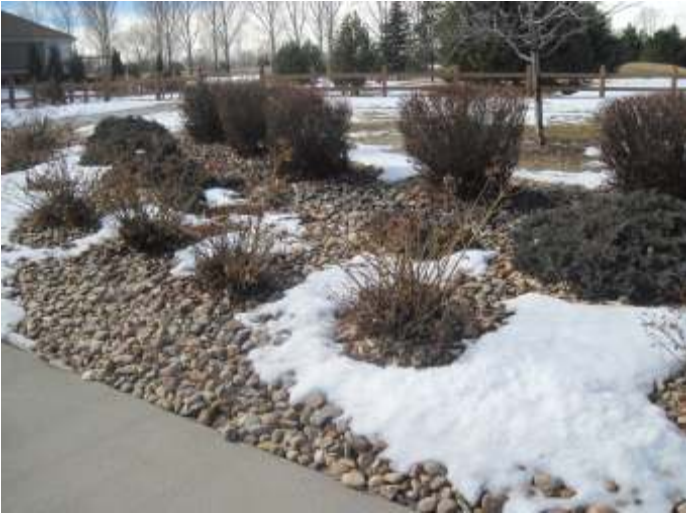
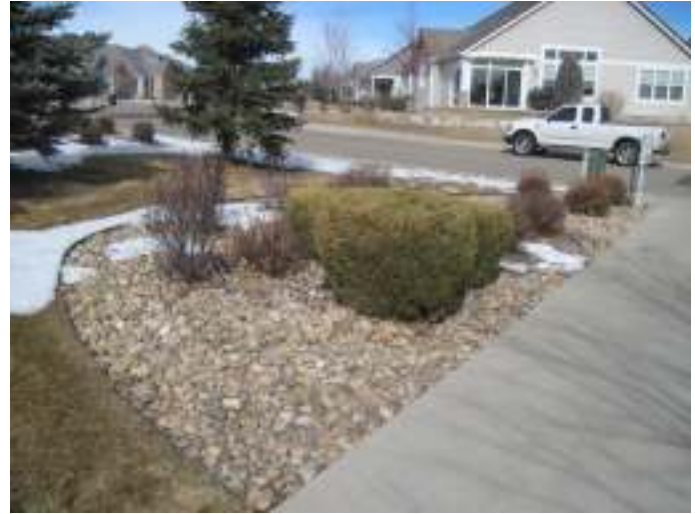
Comp #: 1801 Groundcover - Replenish

Majority of groundcover in the round-abouts is rock and xeriscape type material that does not require excessive watering during summer months. Also, a majority of the surfaces are native, natural grasses which should not require replacement. The sod and the irrigated areas can be repaired and patched as part of grounds maintenance. Since it is difficult to predict when shrubs and trees will die and need replacement, we suggest treating as part of landscape maintenance operating expense. Therefore, no Reserve funding is required for this component.

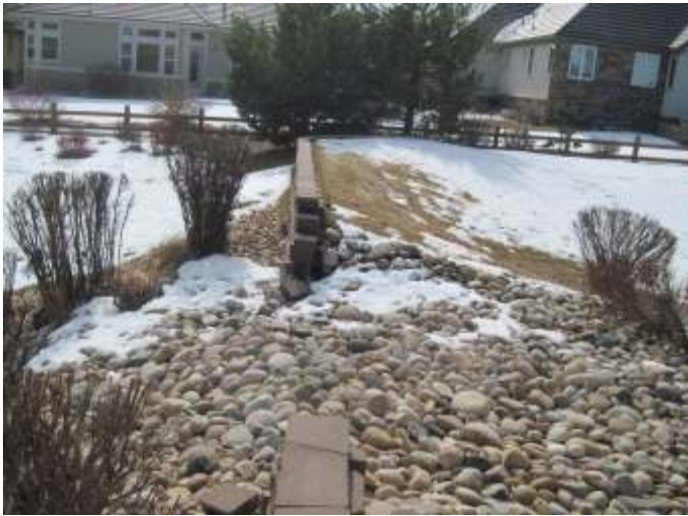
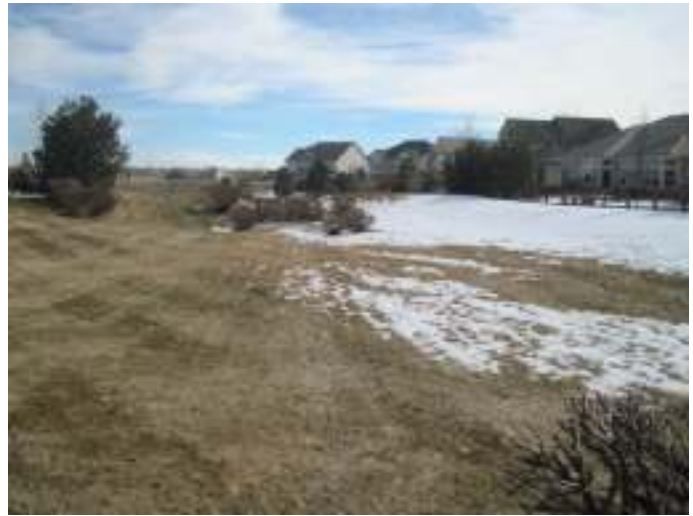
Comp #: 1806 Detention Pond - Rebuild

These detention ponds and flood control basins are in good condition and appear to be designed to handle a "100-year" flood. With general maintenance of groundcover, it is not expected replacement of the components in this area is necessary. Therefore, no Reserve funding is required for this component.
