## **“Full” Reserve Study**

### **Portico (A Country Haven) HOA Longmont, CO**

**Report #: 23988-0**  
**For Period Beginning: January 1, 2013**  
**Expires: December 31, 2013**

**Date Prepared: September 4, 2012**

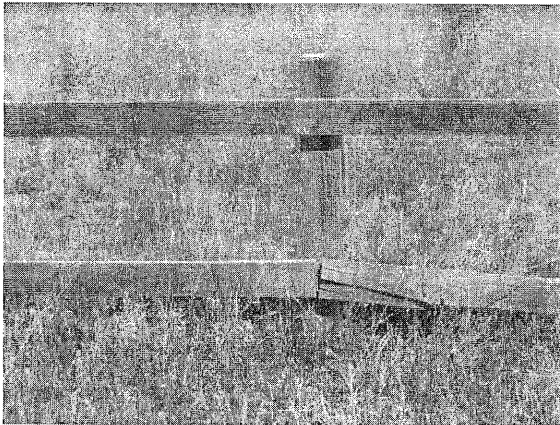
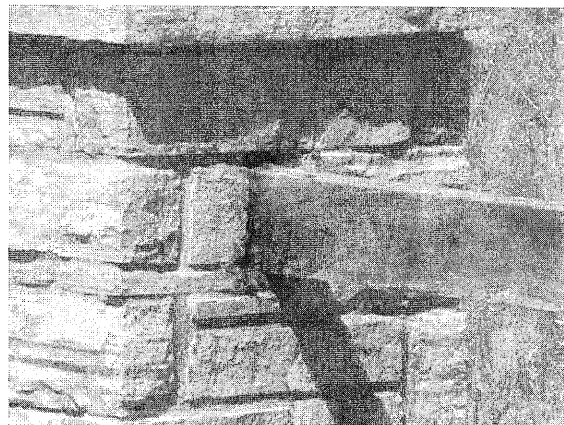
The wood fence appears very dry, with some broken or loose boards. We recommend repairing the board, then the regular application of a high quality wood sealer, to extend the life of this component.

Several of the fence pilasters along Plateau Rd. have become home to honeybees. Insect activity will defeat the mortar seals, allowing water penetration which will caused accelerated deterioration of the posts.

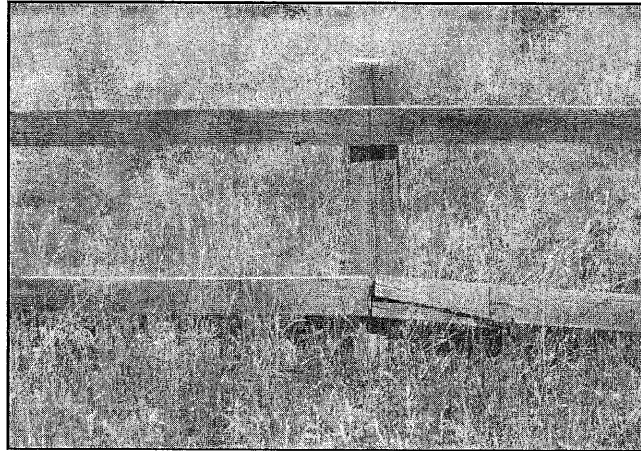
**Comp #:** 505 Wood Rail Fence - Replace

Evaluation: Wood rail fence is in overall fair condition with signs of fading, cracked, broken, warped boards, and loose nails. Useful life may vary depending on grade of cedar used, integrity of posts (how well they are secured), and exposure to the elements. Recommend the regular application of a quality sealer to protect wood surfaces from the elements.

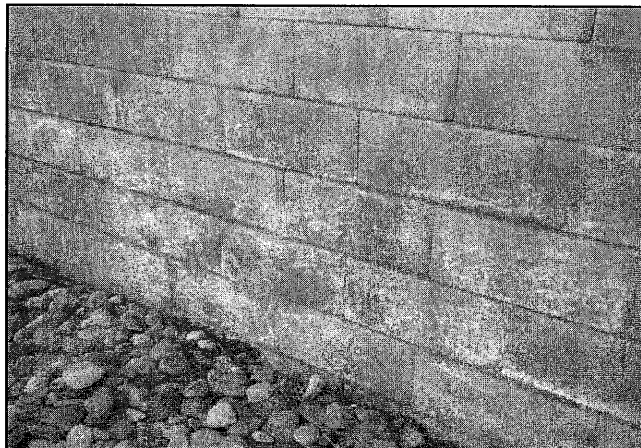
**Comp #:** 510 MSE Wall - Repair

Evaluation: MSE (Mechanically Stabilized Earth Wall) is in overall good condition. Walls are usually constructed with masonry block, geo-grid, select fill material, and drainage pipe at bottom of wall. Recommend periodic inspections to ensure wall is intact and drains are functioning properly.

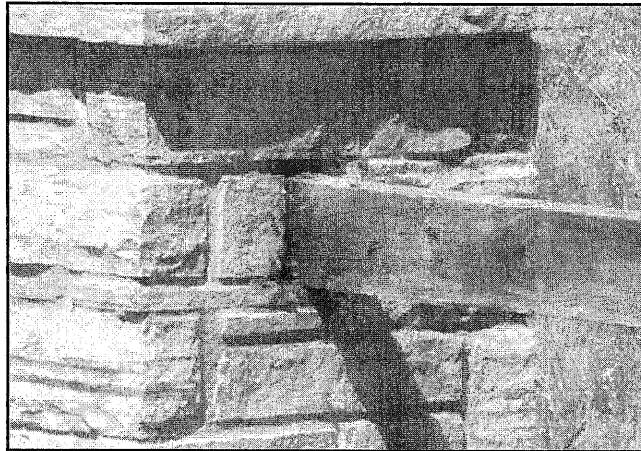
Comp #: 512 Stone Pilasters - Repair (part)

Evaluation: Decorative stone pilasters are incorporated into the fence line, as well as used for signage at The Park. Recommend regular inspections to ensure grout is intact, and loose or missing stones are replaced immediately. Subsurface water penetration, when subject to a freeze-thaw cycle will reduce the life of this component. Several of the pilasters at the Plateau Rd. entrance have become home to honeybee colonies. Insect activity will prevent proper sealing of the structures.

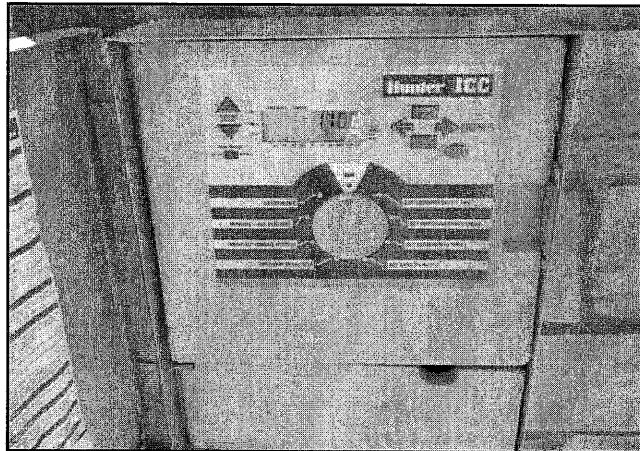
Comp #: 1003 Irrigation System - Replace

Evaluation: The extensive irrigation system consists of several controllers, backflows, heads and pipes. Anticipate regular replacement of major components such as clocks and backflow preventers as the system ages. The landscape company is in the process of taking over the community and has not yet inventoried all of the irrigation equipment. This number may need to be revised after full inventory and evaluation of the equipment has been completed.

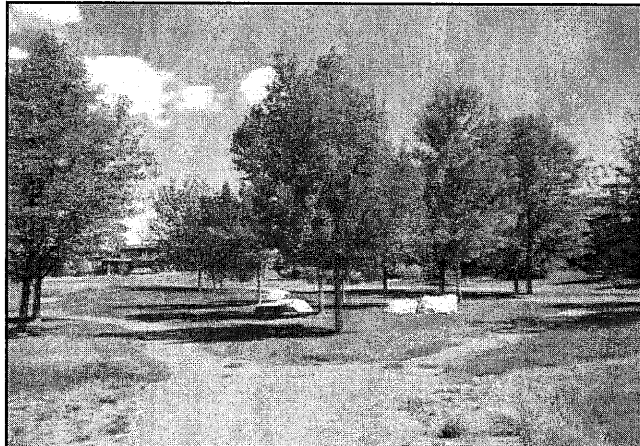
Comp #: 1005 Trees - Replace (part)

Evaluation: Trees and vegetation are mature and appear in overall good condition. Funding is for ongoing replacement of trees and vegetation due to winter kill and disease.

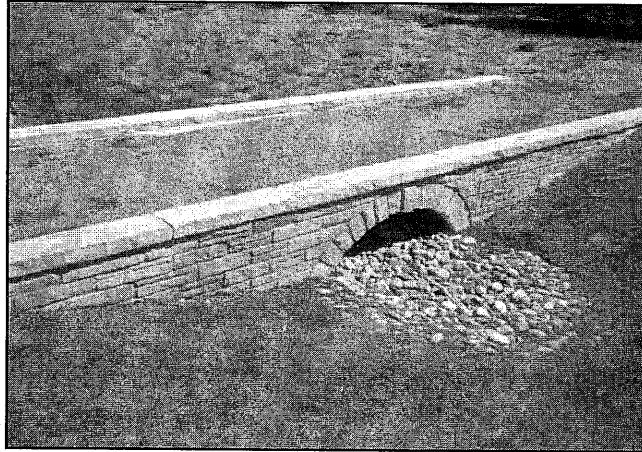
Comp #: 1020 Bridges - Repair

Evaluation: The stone accented bridges enhance The Park trail, and direct water flow away from the granite path. We could not determine the exact construction of the bridges. Funding is for periodic replacement of stone and repointing of grout.

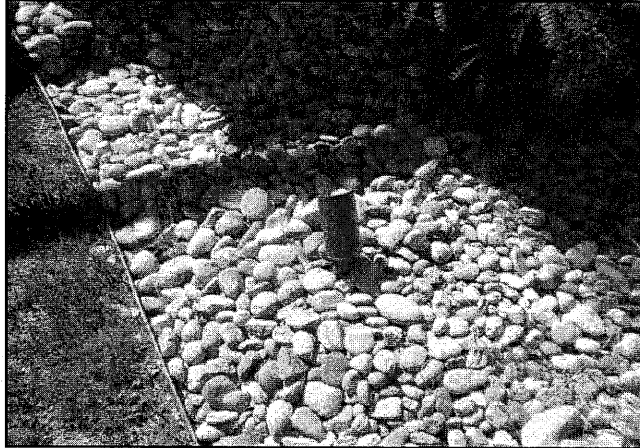
Comp #: 1026 Landscape Lights - Replace

Evaluation: Metal landscape lights, Ambiance 9323-40, are used at the property entrances to highlight trees and signage. Currently (1) light at the Plateau Rd. entrance was broken. Anticipate replacement due to age and wear.

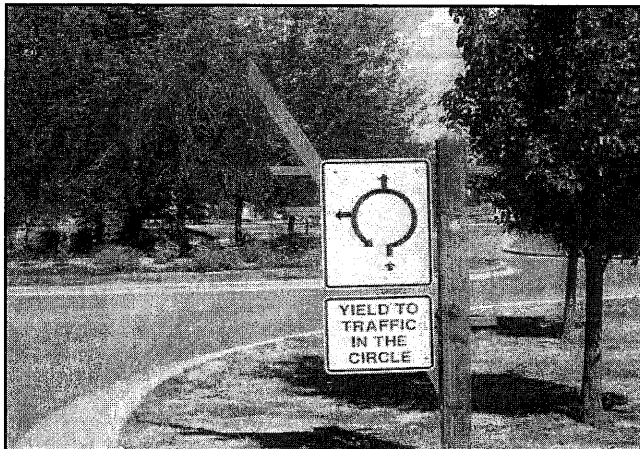
**Comp #:** 1403 Street Signs - Replace

Evaluation: Decorative street signs are located throughout the community providing direction and information. Signs are constructed of 6x6 wood posts with metal accents. Anticipate replacing wood posts periodically due to age and damage. Replacements should be paid through the operating budget.
