**Pinnacle at Ute Creek Homeowners Associa
Longmont, CO**

Report #: 40616-0
Beginning: January 1, 2022
Expires: December 31, 2022

RESERVE STUDY
"Full"

November 15, 2021

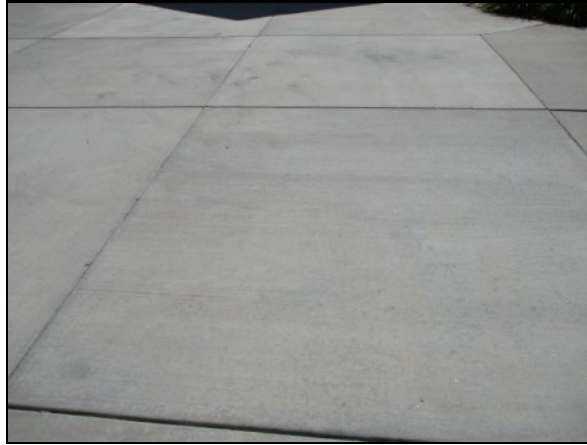
Comp #: 21050 Driveway Concrete - Repair - 5%

Comments: Concrete driveways determined to be in fair condition typically may exhibit small changes in slope and narrow "hair-line" wide cracks. Overall no unusual or extreme signs of age noted. Driveways are reported to be the maintenance and repair responsibility of the client. Although complete replacement of all areas together should not be required conditions observed merit inclusion of an allowance for ongoing repairs and partial replacements. Exposure to sunlight weather and frequent vehicle traffic can lead to larger more frequent repairs especially for older properties. Inspect all areas periodically to identify trip hazards or other safety issues. Timeline and cost ranges shown here should be re-evaluated during future Reserve Study updates.

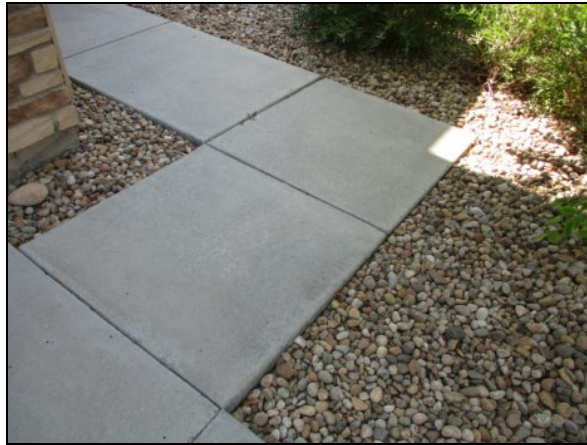
Comp #: 21090 Conc. Walkways/Patios - Repair - 5%

Comments: Concrete determined to be in fair condition typically exhibit minor changes in slope and a moderate percentage of cracking and surface wear. Trip hazards may be increasing in frequency and severity and should be closely monitored to prevent further risks. The Rocky Mountain Region is home to expansive soils. One of the causes of concrete damage in this type of soil moisture. Expansive soils tend to swell in size when wet and contract as they dry out. As the soil expands and contracts it can create enough force to cause major damage to sidewalks. Repair any trip and fall hazards immediately to ensure safety. As routine maintenance inspect regularly pressure wash for appearance and repair promptly as needed to prevent water penetrating into the base and causing further damage. In our experience larger repair/replacement expenses emerge as the community ages. Although difficult to predict timing cost and scope we suggest a rotating funding allowance to supplement the operating/maintenance budget for periodic larger repairs. Adjust as conditions actual expense patterns dictate within future reserve study updates.

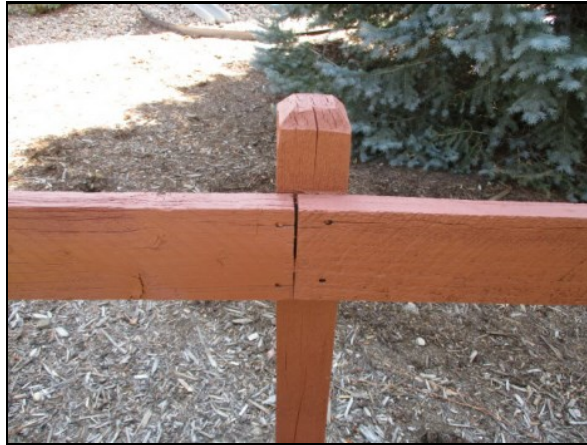
Comp #: 21320 Site Fencing: Wood - Repair/Paint

Wood fencing determined to be in poor condition typically exhibits more advanced deterioration of coating with notable wear possibly resulting in rotting of wood structure in places. Poor inconsistent curb appeal. Regular uniform professional paint or sealer applications are recommended for appearance protection of wood and maximum design life. Repair as needed and clean prior to application. Plan for regular applications as shown below. Timing of repair/paint cycles may need to be coordinated with eventual fence replacement.

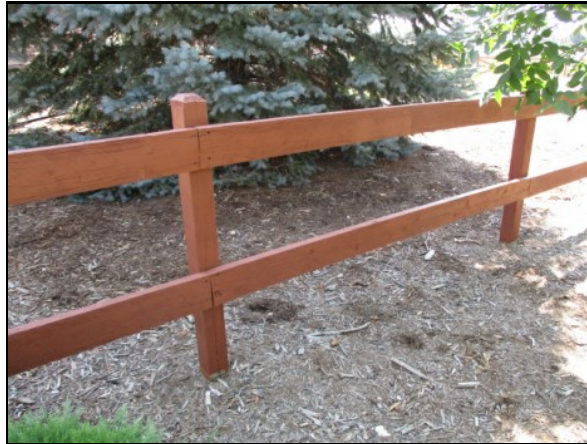
Comp #: 21340 Site Fencing: Split Rail - Replace

Wood fencing determined to be in fair condition typically exhibits some minor to moderate amounts of surface wear and other signs of age which may include a small percentage of warped split and/or rotted sections. In general appearance is consistent but declining. As routine maintenance inspect regularly for any damage repair as needed and avoid contact with ground and surrounding vegetation wherever possible. Regular cycles of uniform professional sealing/painting will help to maintain appearance and maximize life. In our experience wood fencing will typically eventually break down due to a combination of sun and weather exposure which is sometimes exacerbated by other factors such as irrigation overspray abuse and lack of preventive maintenance. Recommendation and costs shown here are based on replacement with similar style and material. However the client might want to consider replacing with more sturdy lower-maintenance products like composite vinyl etc. Although installation costs are higher total life cycle cost is lower due to less maintenance and longer design life expectancy.

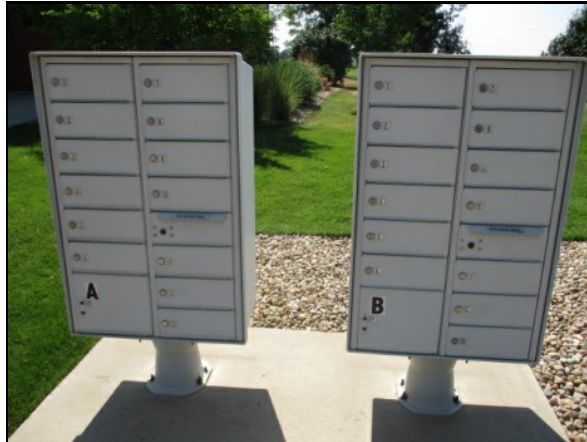
Comp #: 21600 Mailbox Kiosks - Replace

Mailbox kiosks determined to be in fair condition typically exhibit minor to moderate surface wear at this stage. All components and hardware appear to function properly but appearance is diminishing. Inspect regularly and clean by wiping down exterior surfaces. If necessary change lock cylinders lubricate hinges and repair as an Operating expense. Best to plan for total replacement at roughly the time frame below due to constant exposure usage and wear over time. Note USPS has a limited budget for replacement and should not be relied upon for purposes of long term planning.

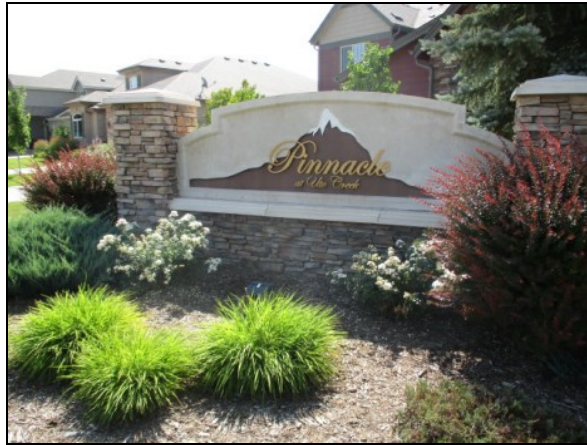
Comp #: 21610 Sign/Monument - Refurbish/Replace

Comments: Monument signage determined to be in fair condition typically exhibits acceptable appearance and aesthetics in keeping with local area but with more weathering and wear showing on surfaces. If present landscaping and lighting are still in serviceable condition. At this stage signage may be becoming more dated and diminishing in appeal. As routine maintenance inspect regularly clean/touch-up and repair as an Operating expense. Plan to refurbish or replace at the interval below. Timing and scope of refurbishing or replacement projects is subjective but should always be scheduled in order to maintain good curb appeal. In our experience most clients choose to refurbish or replace signage periodically in order to maintain good appearance and aesthetics in keeping with local area often before signage is in poor physical condition. If present concrete walls are expected to be painted and repaired as part of refurbishing but not fully replaced unless otherwise noted. Costs can vary significantly depending on style/type desired and may include additional costs for design work landscaping lighting water features etc. Reserve Study updates should incorporate any estimates or information collected regarding potential projects.

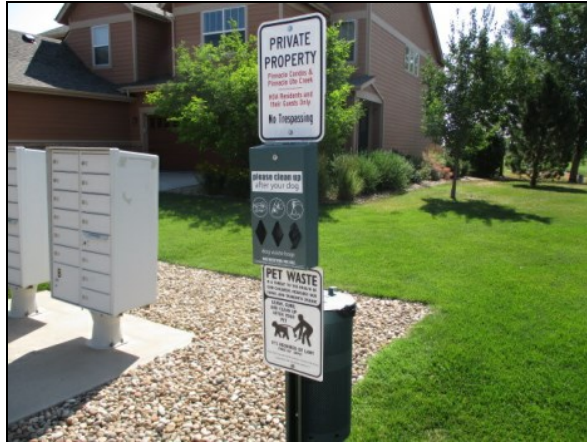
Comp #: 21620 Pet Waste Stations - Replace

Comments: Stations should be inspected regularly to make sure visibility is adequate including at night. Repair any damaged or leaning posts as needed. At this time costs related to this component are expected to be included in the client's Operating budget. No recommendation for Reserve funding at this time. However any repair and maintenance or other related expenditures should be tracked and this component should be re-evaluated during future Reserve Study updates based on most recent information and data available at that time. If deemed appropriate for Reserve funding component can be included in the funding plan at that time.

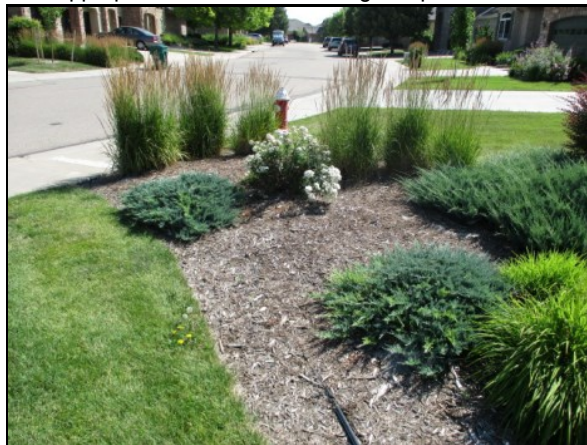
Comments: In general costs related to this component are expected to be included in the client's Operating budget. No recommendation for Reserve funding at this time. However any repair and maintenance or other related expenditures should be tracked and this component should be re-evaluated during future Reserve Study updates based on most recent information and data available at that time. If deemed appropriate for Reserve funding component can be included in the funding plan at that time.

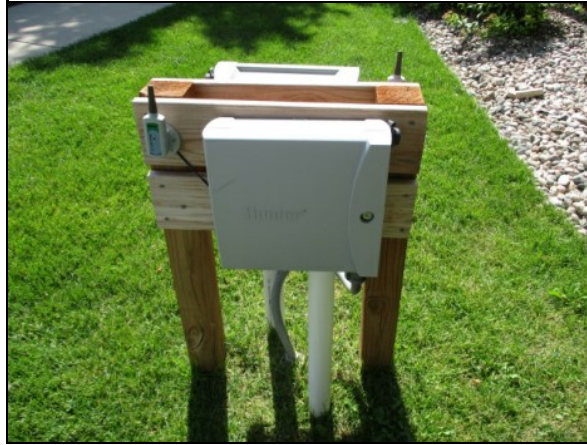
Comp #: 25570 Irrigation Clocks - Replace

Comments: Client reported that the association is responsible for only 38% of the costs for this component. As such, costs fall below threshold for reserve funding. Plan to fund replacement as an Operating expense.
