"Full" Reserve Study

Rainbow Lake Estates Berthoud, CO

Report #: 32564-0
For Period Beginning: January 1, 2018
Expires: December 31, 2018

Date Prepared: June 26, 2017

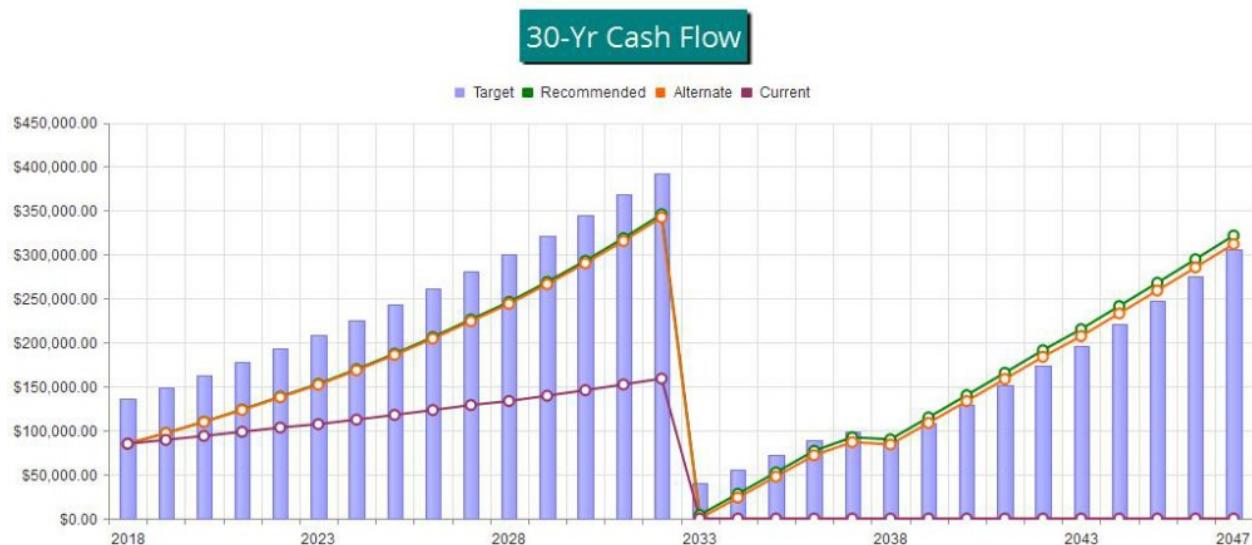
Figure 2

The following chart shows your Reserve balance under our recommended Full Funding Plan, an alternate Baseline Funding Plan, and at your current budgeted contribution rate, compared to your always-changing Fully Funded Balance target.

Based on your current Percent Funded and your near-term and long-term Reserve needs, we are recommending budgeted contributions of \$11,218 Annual. The overall 30-yr plan, in perspective, is shown below. This same information is shown numerically in both the 30-yr Summary Table and the Cash Flow Detail Table.

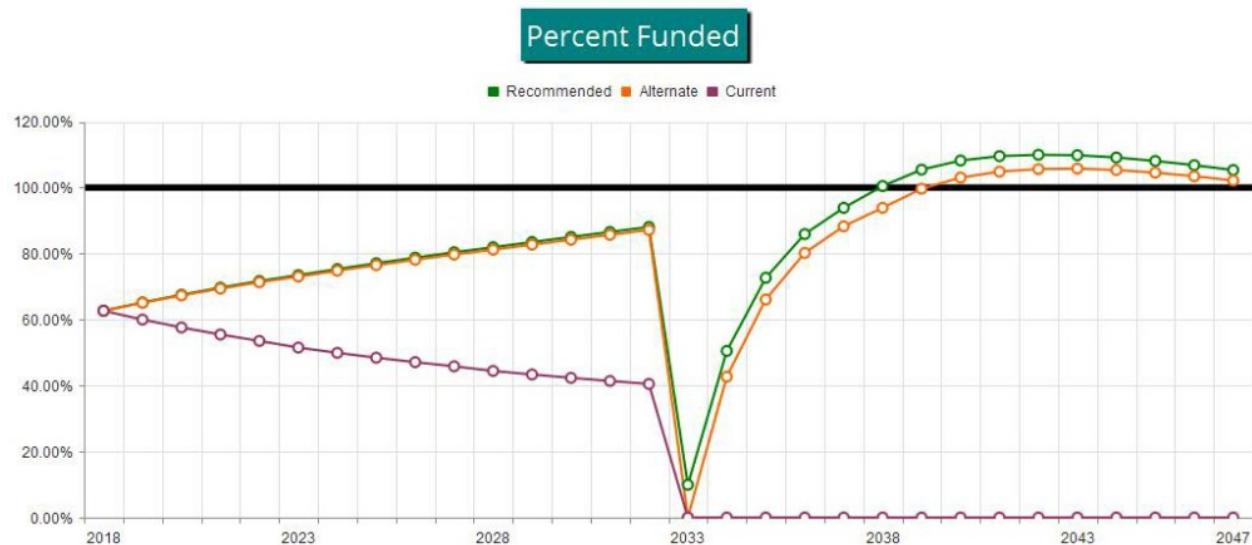
Figure 3

This figure shows the same information plotted on a Percent Funded scale. It is clear here to see how your Reserve Fund strength approaches the 100% Funded level under our recommended multi-yr Funding Plan.

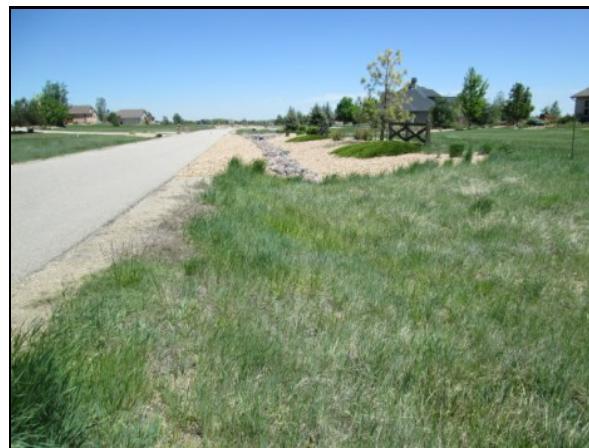
Comp #: 2117 Site Drainage System - Clean/Repair

Evaluation: Site drainage systems determined to be in good condition typically do not cause any noteworthy flooding and/or standing water after normal rain storms. All system components are presumed to be functional and aging normally. No unusual conditions reported by the Association. No access to inspect in-ground drainage infrastructure. Annual preventive maintenance work is typically performed as part of an Association's general maintenance/operating fund. Under normal circumstances, site drainage components are constructed of very durable materials which should have a very long useful life (often assumed to be 50 years or more). Repairs may occasionally be required, but timing and scope of work is too unpredictable for Reserve funding in accordance with National Reserve Study Standards. If there are specific, known concerns with drainage system, we recommend further investigation using cameras or other means to document and identify conditions. Some Associations consult with civil and/or geotechnical engineers in order to develop scopes of work for repair/replacement. If more comprehensive analysis becomes available, findings should be incorporated into Reserve Study updates as appropriate.

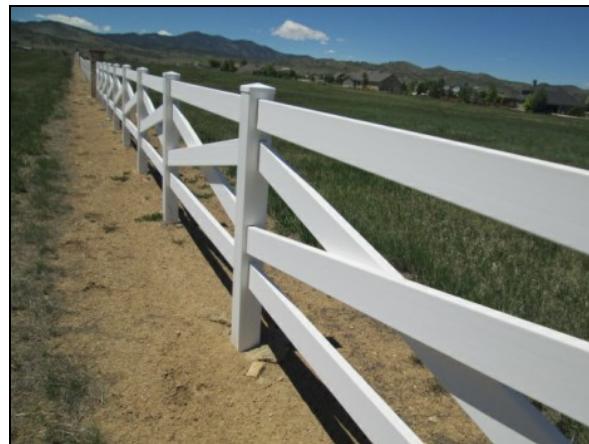
Comp #: 2159 Site Fencing: Vinyl - Replace**Quantity: ~ 12000 LF**

Evaluation: Vinyl fencing determined to be in good condition typically exhibits little to no apparent surface wear or damage. Physically, fencing is straight and upright with no warped, cracked or damaged sections. Appearance is good and appropriate for curb appeal within the development. 4' high split rail style vinyl fence was noted on site inspection. As routine maintenance, inspect regularly for any damage and repair as needed from Operating budget; pressure-clean as a general maintenance item or along with larger building projects, not as separate Reserve item. Even with proactive maintenance, plan to replace at roughly the time frame below due to damage/deterioration that will result from constant exposure.

Useful Life:
30 yearsRemaining Life:
14 years

Best Case: \$ 220,000

Worst Case: \$ 264,000

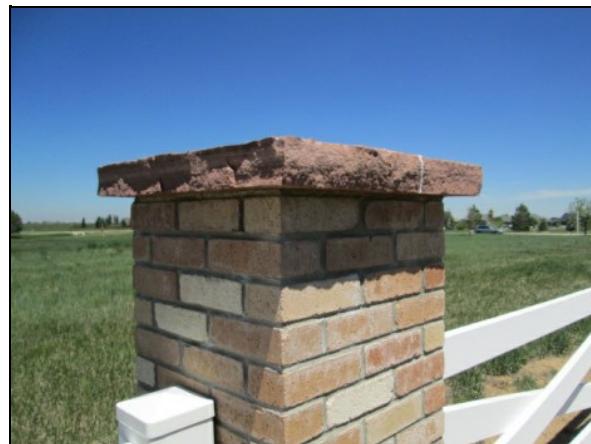
Comp #: 2166 Perimeter Brick Pillars - Repair**Quantity: ~ (52) Pillars**

Evaluation: The pillar surfaces appeared in generally good condition. No broken or missing sections observed. No cracking, fading, or weathering noted. At this time, costs related to this component are expected to be included in the Association's Operating budget. No recommendation for Reserve funding at this time. However, any repair and maintenance or other related expenditures should be tracked, and this component should be re-evaluated during future Reserve Study updates based on most recent information and data available at that time. If deemed appropriate for Reserve funding, component can be included in the funding plan at that time.

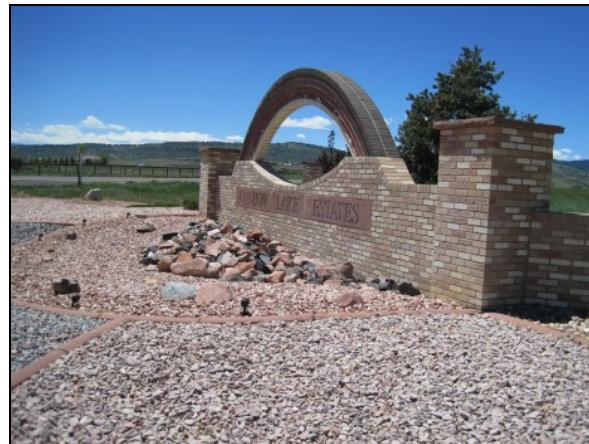
Evaluation: Monument signage determined to be in good condition typically exhibits good appearance and aesthetics in keeping with local area. Generally uniform and attractive finishes. If present, lettering is clean, complete and legible and any surrounding landscaping, lighting, etc. is attractive and functioning. As routine maintenance, inspect regularly, clean/touch-up and repair as an Operating expense. Plan to refurbish or replace at the interval below. Timing and scope of refurbishing or replacement projects is subjective but should always be scheduled in order to maintain good curb appeal. In our experience, most Associations choose to refurbish or replace signage periodically in order to maintain good appearance and aesthetics in keeping with local area, often before signage is in poor physical condition. If present, concrete walls are expected to be painted and repaired as part of refurbishing, but not fully replaced unless otherwise noted. Costs can vary significantly depending on style/type desired, and may include additional costs for design work, landscaping, lighting, water features, etc. Reserve Study updates should incorporate any estimates or information collected regarding potential projects.

Remaining Life:

19 years

Best Case: \$ 10,000

Worst Case: \$ 15,000

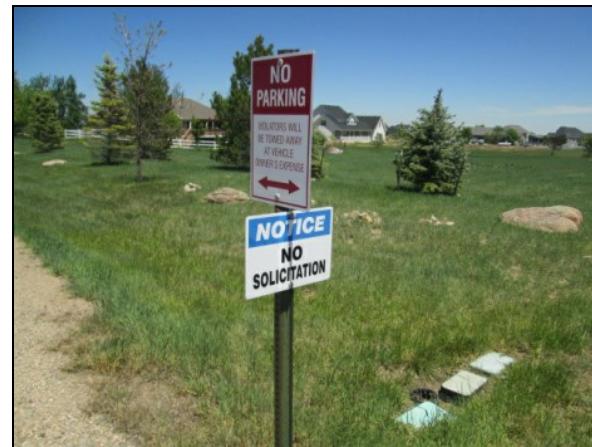
Comp #: 2183 Signs/Pet Stations - Replace**Quantity: ~ (11) Signs**

Evaluation: Directional and street signs determined to be in fair condition typically exhibit somewhat faded surface finish and may have minor damage to their supports/posts/hardware. Panels are clean but reflectiveness and contrasting of lettering or symbols may be diminished. Street signs and posts are generally replaced at longer intervals due to weathering or style changes, or to coincide with other exterior projects such as replacement of entry signage, street lighting, etc. Signs should be inspected regularly to make sure visibility is adequate, including at night. Repair any damaged or leaning posts as needed. At this time, costs related to this component are expected to be included in the Association's Operating budget. No recommendation for Reserve funding at this time. However, any repair and maintenance or other related expenditures should be tracked, and this component should be re-evaluated during future Reserve Study updates based on most recent information and data available at that time. If deemed appropriate for Reserve funding, component can be included in the funding plan at that time.

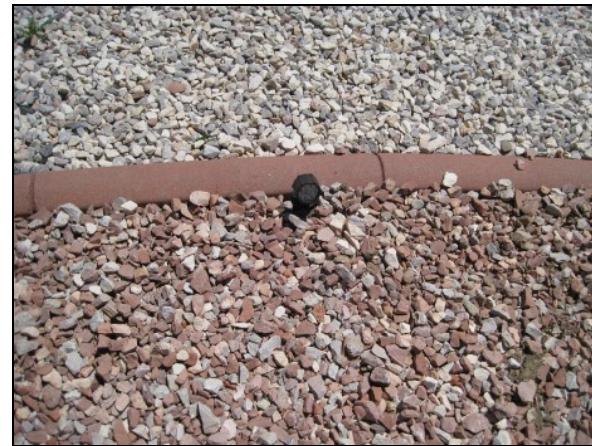
Comp #: 2189 Landscape Lights - Replace**Quantity: ~ (32) Lights**

History: Replaced in 2016

Evaluation: Landscape lights should be inspected periodically to ensure proper function and adequate lighting in all areas. We recommend consideration of LED fixtures or other energy-saving options whenever possible. Landscape lights should be inspected periodically to ensure proper function and adequate lighting in all areas. We recommend consideration of LED fixtures or other energy-saving options whenever possible. Individual fixtures should be replaced as needed as an Operating expense.

Useful Life:
20 years

Remaining Life:
18 years

Best Case: \$ 5,000

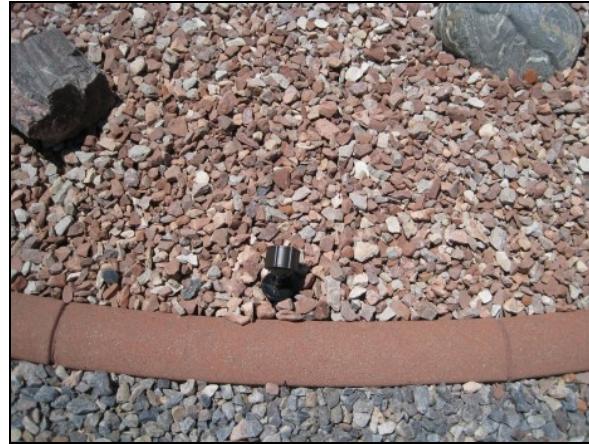
Comp #: 2189 Landscape Lights - Replace (2017)**Quantity:** ~ (8) Lights

Evaluation: Landscape lights should be inspected periodically to ensure proper function and adequate lighting in all areas. We recommend consideration of LED fixtures or other energy-saving options whenever possible. Individual fixtures should be replaced as needed as an Operating expense.

Useful Life:
20 yearsRemaining Life:
19 years

Best Case: \$ 1,000

Worst Case: \$ 3,000

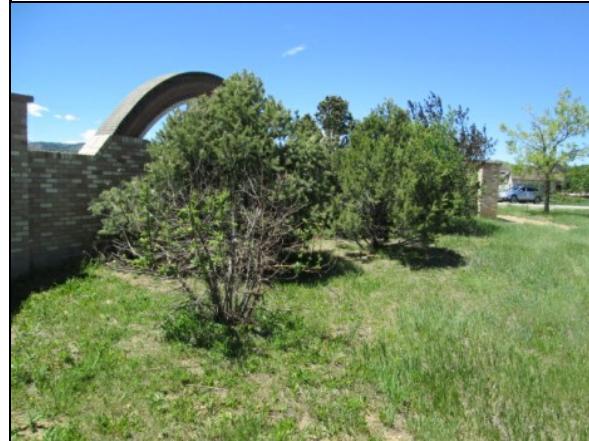
Evaluation: Routine tree trimming is expected to be included within the association's landscaping contract or otherwise reflected in the annual Operating budget. No need for Reserve funding at this time. If a pattern of larger expenses develops, or if substantial removal or replacement becomes necessary, the Reserve Study should be updated to incorporate new information. In this case, many Associations choose to work with a qualified arborist or other landscaping professional to develop appropriate guidelines and scope of work.

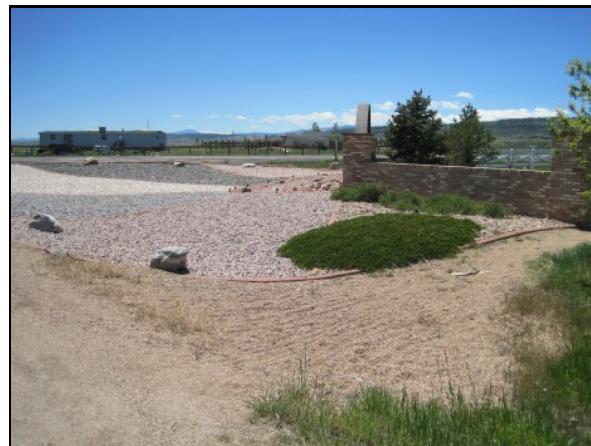
Evaluation: Landscaping costs are expected to be included in the Association's annual Operating budget. No recommendation for Reserve funding at this time. Monitor and include funding in Reserve Study updates if needed.

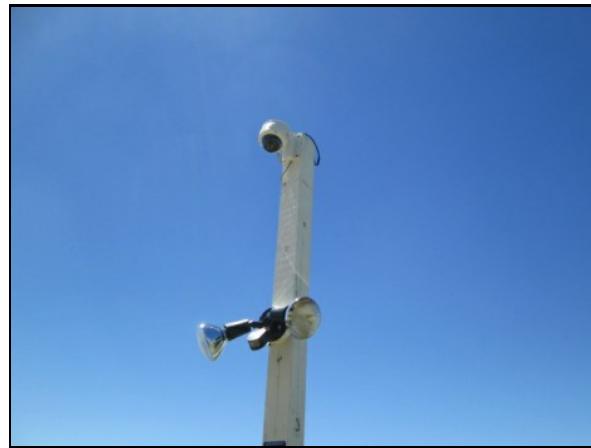
History: Repaired in 2017

Evaluation: Minimal or no subjective/aesthetic value for this component. Useful life is based primarily on normal expectations for service/performance life in this location. Unless otherwise noted, remaining useful life expectancy is based primarily on original installation or last replacement/purchase date, our experience with similar systems/components, and assuming normal amount of usage and good preventive maintenance. Security/surveillance systems should be monitored closely to ensure proper function. Whenever possible, camera locations should be protected and isolated to prevent tampering and/or theft. Typical modernization projects may include addition and/or replacement of cameras, recording equipment, monitors, software, etc. Unless otherwise noted, costs assume that existing wiring can be re-used and only the actual cameras and other equipment will be replaced. In many cases, replacement or modernization is warranted due to advancement in technology, not necessarily due to functional failure of the existing system. Keep track of any partial replacements and include cost history during future Reserve Study updates.

Useful Life:
5 years

Remaining Life:
4 years

Best Case: \$ 800

Worst Case: \$ 1,200
